STATE OF CALIFORNIA  
DEPARTMENT OF PUBLIC WORKS  
DIVISION OF HIGHWAYS

DYNAMIC FULL SCALE IMPACT TESTS  
OF  
CABLE TYPE MEDIAN BARRIERS  
TEST SERIES VII

MARCH 1964

Proj. W. O. R-62280  
Hdqtrs. W. O. 62-19U51H21

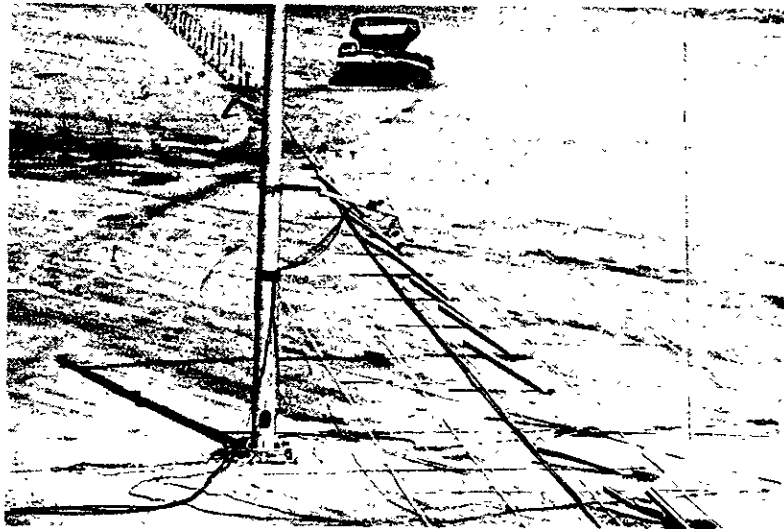
A. TEST NO. 4 - 25° at 83 MPH

It has been found that this violent spin-out is also a problem on wide angle impacts (25 degrees or more) when the speeds are excessively high (80 mph and over). The extreme and excessive deflections (17 ft. and over) coincidental with these high speeds permit the vehicle to tension the cables like bow strings. The restitutional forces in the system can cause the cables to flip the vehicle off the barrier rather than redirecting it on a new course parallel to the barrier (see Exhibit 5-A).

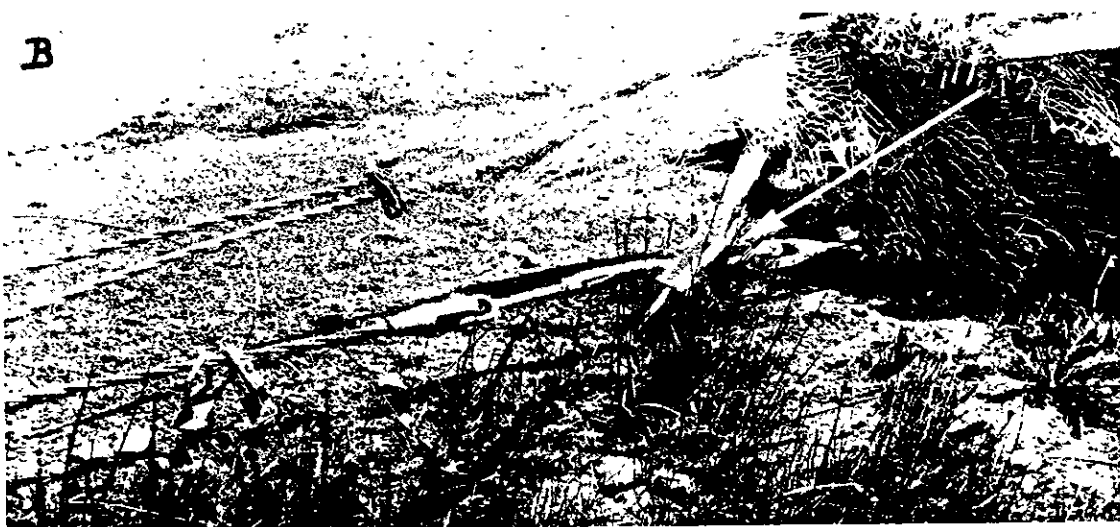
B. Close-up of Turnbuckle Trapped on Post.

Past experience with the open type turnbuckle (Exhibit 3-B) during controlled impact tests has proven that entrapment can be a problem. Researchers at the General Motors Proving Ground (Reference 3) reported that vehicle entrapment on a turnbuckle was a serious problem, especially when a colliding vehicle contacts an open type turnbuckle that is extended its full 3 ft. length (see Exhibit 7-A and B). As shown in these exhibits, the mesh and "U" clamps have gathered on the cable and jammed at the turnbuckle. This entrapment of the mesh and "U" clamps contributed to the violent spin-out of the vehicle and subsequent heavy damage to the vehicle and anchor. Exhibit 7-B also shows the entrapment of the turnbuckle on the post by the "U" clamp. During the 1961 tests it was found that this entrapment was a serious problem and the recommendation was made that if a turnbuckle was located at or within 6" of a post, the "U" clamp should be deleted and the turnbuckle fastened to the post with tie wires.

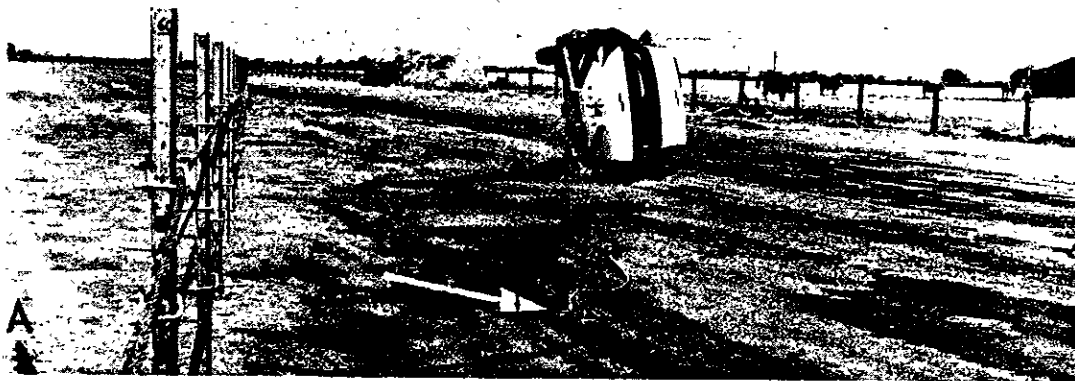
A. Failure of Preformed Splice in 1961 Test.

The first application of the preformed cable splice was made during the 1961 test series where it was proven inadequate when installed as a full tension member connecting a severed cable in the system. This method of splicing cables has proven valuable and efficient when applied to statically loaded cables such as used on power pole grips and high tension electrical transmission cables. However, during a dynamic type of loading such as occurs during a vehicle impact, the exposed ends of the preformed splice rods can catch on the vehicle body as it slides along the cables. This catching can release one end of the cable from the unit much in the same manner as the Chinese finger sleeve releases the fingers when compressed from either end. However, the release during the 1961 test occurred after the vehicle had started its spin-out, otherwise the vehicle would have penetrated over the barrier. Exhibit 8-A is a post-impact view of this test showing the preformed splice still attached to one end of the cable.

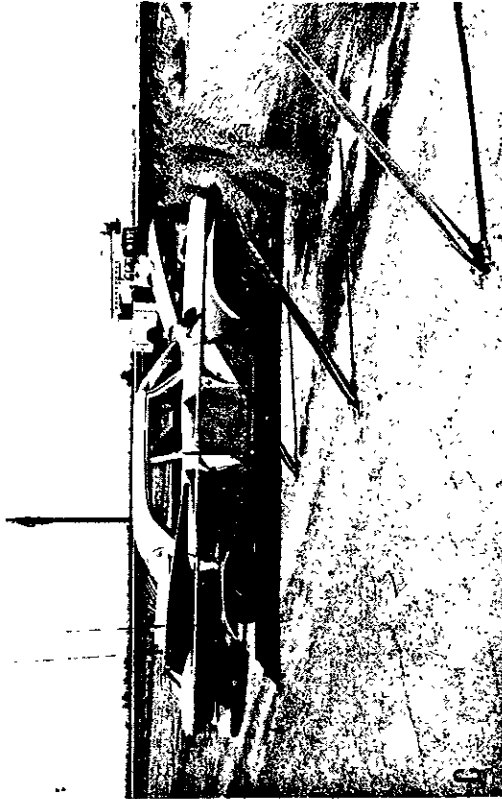
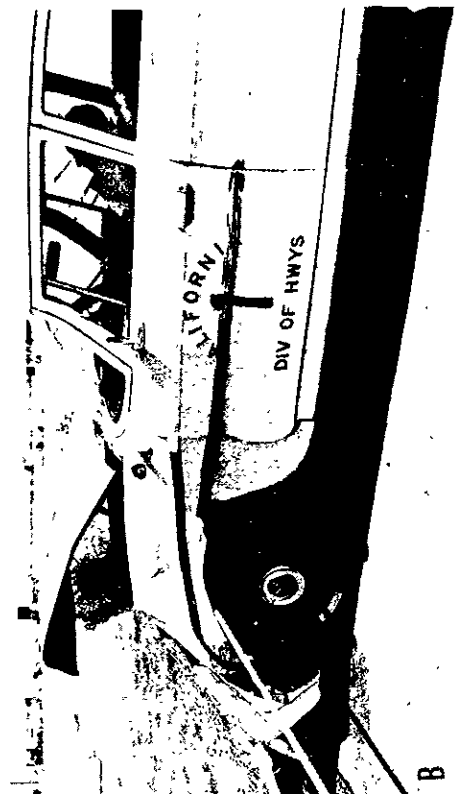
TEST NO. 2 VEHICLE AND BARRIER DAMAGE

**BARRIER DAMAGE (See Exhibit 10):** The rear cable anchor was jerked from the ground and rolled 56 feet toward the point of impact (Exhibit 10-D). Thirty-seven posts were bent beyond repair. The turnbuckles were bent requiring replacement of one of the studs (see Exhibit 10-B).

**PERFORMANCE:** See Exhibits 10 and 14. An adequate analysis of the performance of this barrier in relation to the purpose of the test cannot be made because of the failure of the anchor block approximately half way through the run. The anchor failed because the backfill material placed during the repairs after Test No. 1 was wet and not thoroughly compacted. However, all wheels remained on the pavement until the vehicle crossed over the cables and spun around approximately 300 degrees. During the spin, the left rear wheel left the pavement and the vehicle rolled to the right. The turnbuckles passed through the vehicle body with no evidence of snagging.

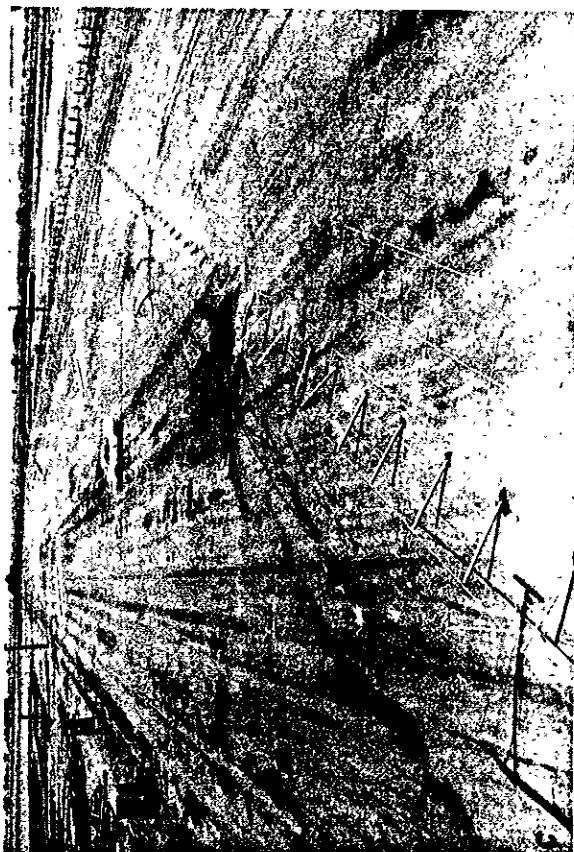
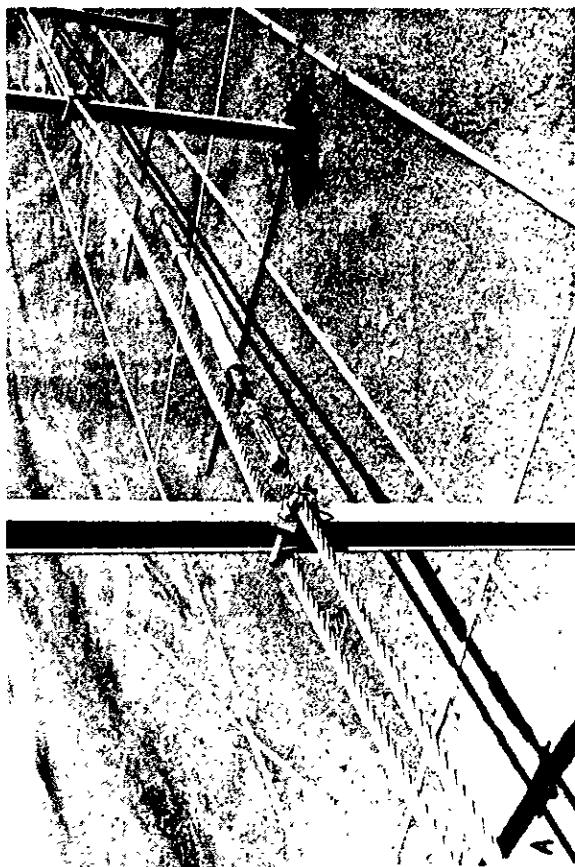
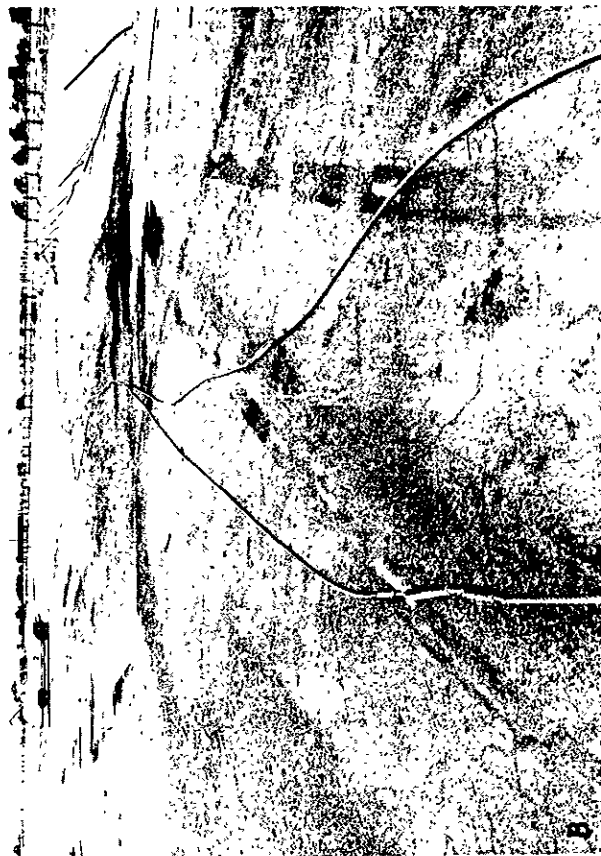
TEST NO. 3 VEHICLE AND BARRIER DAMAGE

**BARRIER DAMAGE** (see Exhibit 11): 29 posts bent beyond repair. Turnbuckles were bent requiring replacement of two studs. Cables were frayed slightly (loss of less than 25% of cross section) requiring installation of a preformed patch rod kit on the damaged section before Test No. 4 (see Exhibit 12-A and B).

**PERFORMANCE:** (See Exhibit 15). All wheels remained on the pavement throughout the run. Smooth deceleration to a 180 deg. spin-out at 200 ft. from impact. The Crosby clips were installed backwards on one cable. The cable slipped two feet during the impact (see Exhibit 11-B).

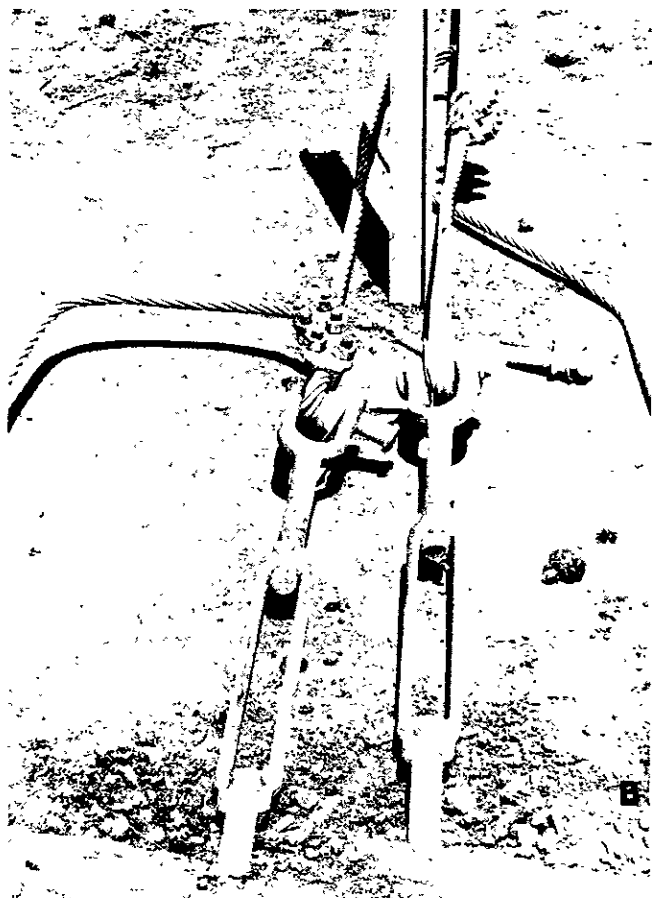
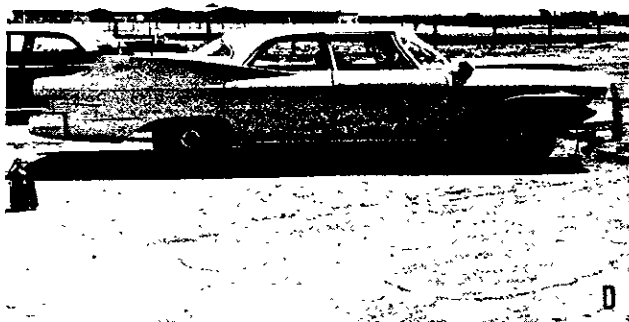
TEST NO. 4 VEHICLE AND BARRIER DAMAGE

It may be noted that in Test No. 4 (Exhibit 12-C) one of the posts was pulled from its socket. Close examination of the post socket revealed 4 inches of water in the bottom of the can. Improper drainage of the socket prior to filling it with asphalt resulted in poor adherence of the asphalt to the can. However, in construction practice, this deficiency would not be encountered. The contractor's normal procedure is to place the post in the can and fill it with asphalt prior to placement of the post/can unit in the hole for the final pouring of the concrete footing.

Exhibits 12-A, B, and C show the damaged cable before repair, after repair with preformed splice, and after impact. Exhibit 12-A shows that the cable was not completely severed before installation of the preformed splice. For this test the preformed splice rods were used only to reinforce this damaged section. Note the frayed ends of the splice adjacent to the post in Exhibit 12-C. During this particular test, the sliding post (pulled from its socket during impact) contacted and frayed the end of the preformed splice. Had the preformed splice been acting as a full tension member rather than as a reinforcing member, the cable would have been released. It is therefore recommended that when splices are required in the tension cables, conventional 3/4 inch cable clips (Crosby Clips) be used. Exhibit 8-B shows the recommended method of making a field splice in the 3/4" tension cables. It should be noted that any splice of this type will develop only 80% of the breaking strength of the cable. Exhibits 8-C and D show the proper and improper methods of terminating a cable in a clevis. Note that in Exhibit 8-C the grip of the clip is properly placed on the "live" end of the cable. Refer to Exhibit 11-B and note that the grip of the clips was improperly placed on the "dead ends" on both cables. Note also that the clevis pin on the left hand cable had slipped, almost releasing the cable. This was a result of the cable snapping off the thimble and rolling over the pin as the cable slipped through the improperly placed clips. However, had the safety cotter pin been inserted in the clevis pin, this problem would not have developed. The recommended spacing for the cable clips is 4 inches on centers, and a minimum of four clips are required on any splice or dead end to develop the specified 80% of the cable strength.

BARRIER DAMAGE (see Exhibit 12): 27 posts were bent beyond repair, and 1 post pulled out. The preformed splice was damaged beyond repair, but there was no further damage to the cable.
